DEPARTMENT OF NATURAL RESOURCES  
DIVISION OF OIL, GAS AND MINING

RE: Site Inspection, H&H Stone, Holley Project, S/037/117, San Juan County, Utah

Date of Inspection: October 7, 2003

S/037/117, Holley Project, H&H Stone

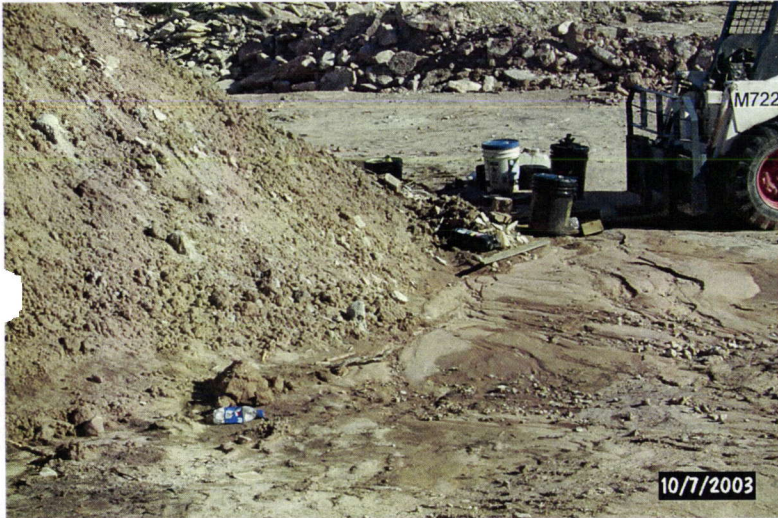
I found 15 hydraulic oil buckets (Photo 1), but only four of them contained any oil. There was also a 55-gallon drum that had some liquid I assume to be oil.

There were several pop bottles and cans, potato chip cans, and other trash lying around.

**Photo 1.** Some of the oil containers and trash at the base of an overburden or soil pile.

The trash needs to be cleaned up. Empty containers should be removed unless they will be reused, and anything remaining should be stored neatly.

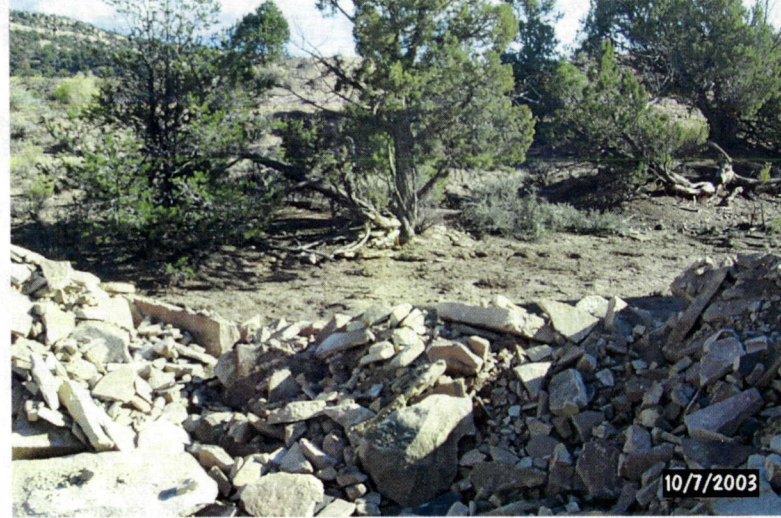
The site is basically at the bottom of an ephemeral drainage, and there was evidence of recent flow through the quarry. Where the main drainage enters the site on the southwest, rock—probably waste rock—had been placed in what amounts to a berm (Photo 3). Water ponded behind this berm (Photo 4) and appeared to have topped it without washing it out.

The waste rock berm above the quarry served as a settling pond for sediment in the runoff from off site areas above the quarry. Undesigned ponds can fail and cause additional sedimentation, but the probability of failure appears to be small. Even if it was to fail, there would not be much additional sediment added to the water, and as long as the berm is present, it reduces the amount of sediment in the runoff.

**Photo 3.** Waste rock berm or dam in the drainage at the southwest part of the quarry.

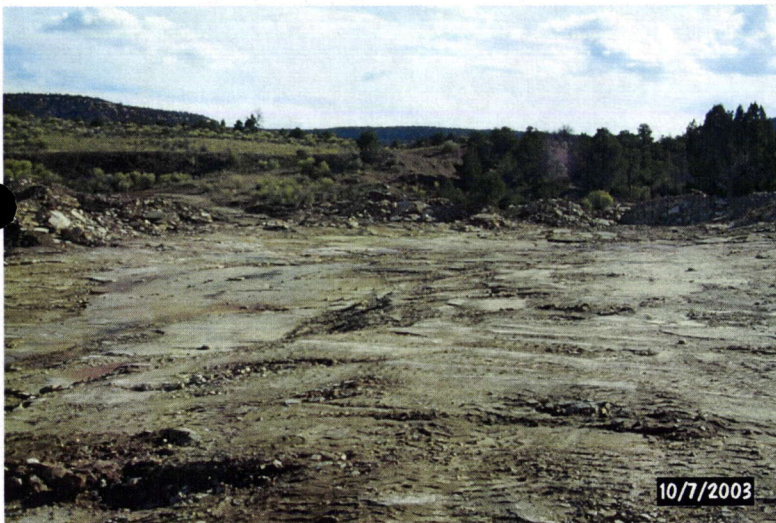
**Photo 2.** An overview of part of the site looking approximately south.

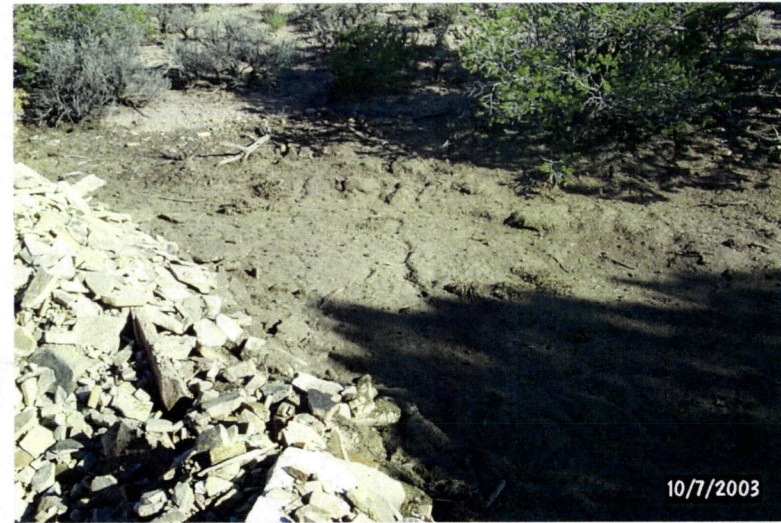
**Photo 4.** Debris that was caught behind the berm shown in Photo 3.

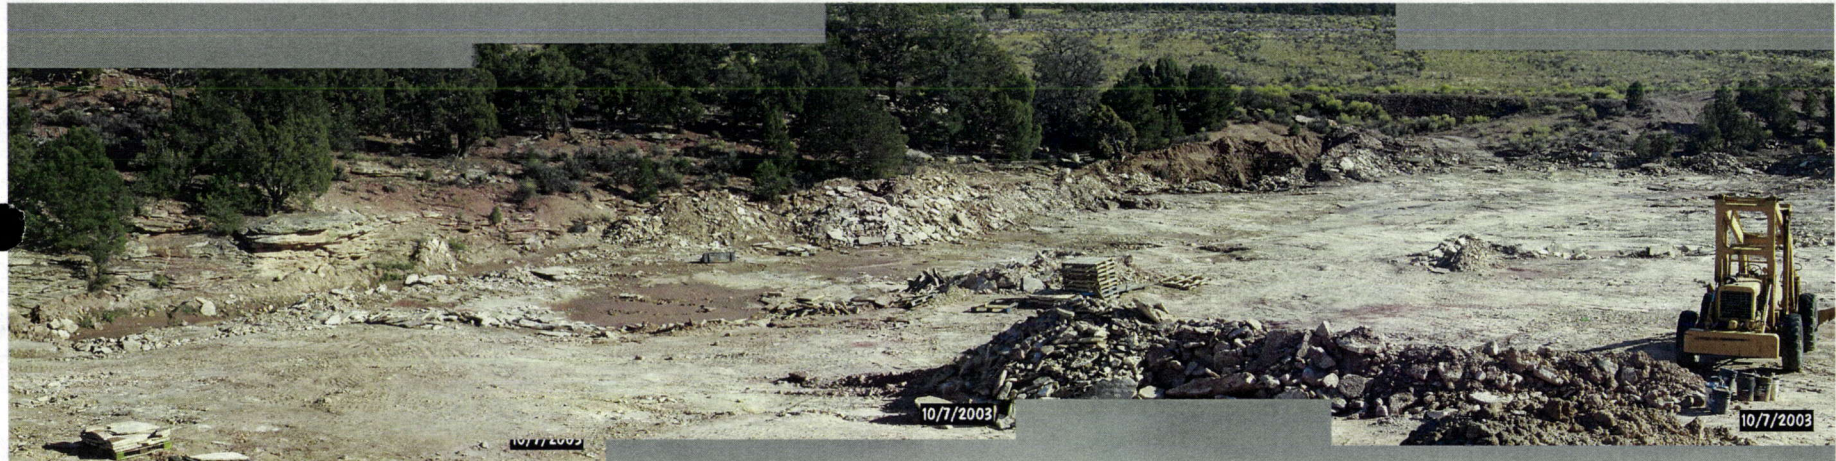
**Photo 5. Composite photo showing much of the quarry.**
